REPLACING OLD WINDOWS?

Sealed double glazing units from the period of 1965 - 1975 may contain PCB and must be handled as hazardous waste.

Older sealed double glazing windows - a source for PCB

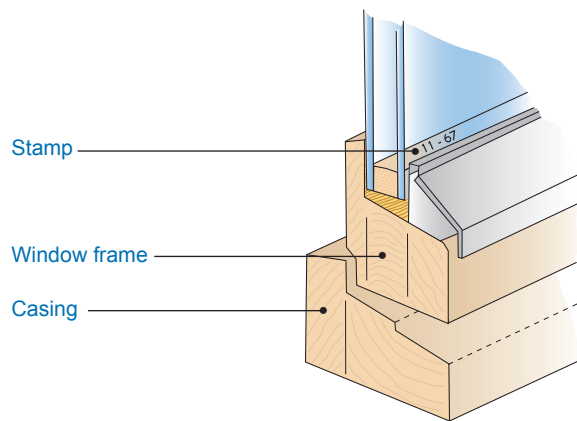
Section of sealed double glazing window with stamp, window frame and casing

Normally, the production year that is stamped in the spacer between the window panes, is a good indicator whether the window contains PCB or not. For example if the stamp shows "11-67", then the window was manufactured during November 1967 and is likely to contain PCB.
